TEST REPORT

NON-LOADBEARING WALL

Name of sponsor:	Ovacon AB		
Product name:	None		
File no.:	PGA12062A	Revision no.:	0
Test date:	16-12-2021	Date:	16-02-2022
Pages:	9	Encl.:	25
Ref:	KLK	/	JBK

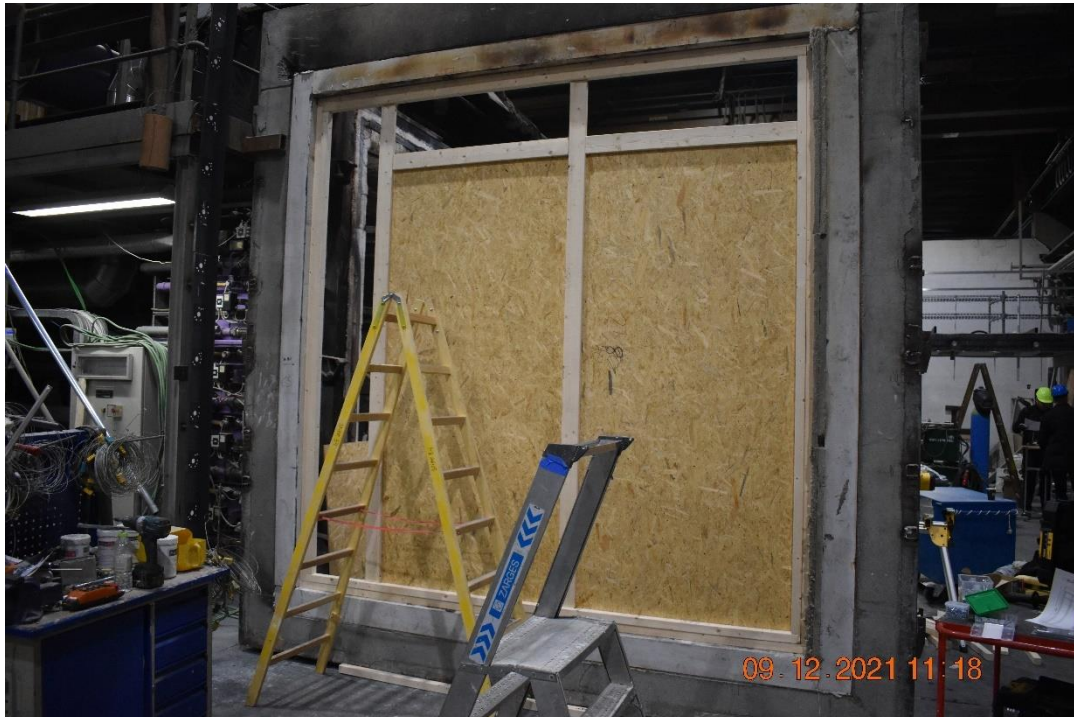
Photo No. 1 Wood frame, studs and OSB wall during mounting process.

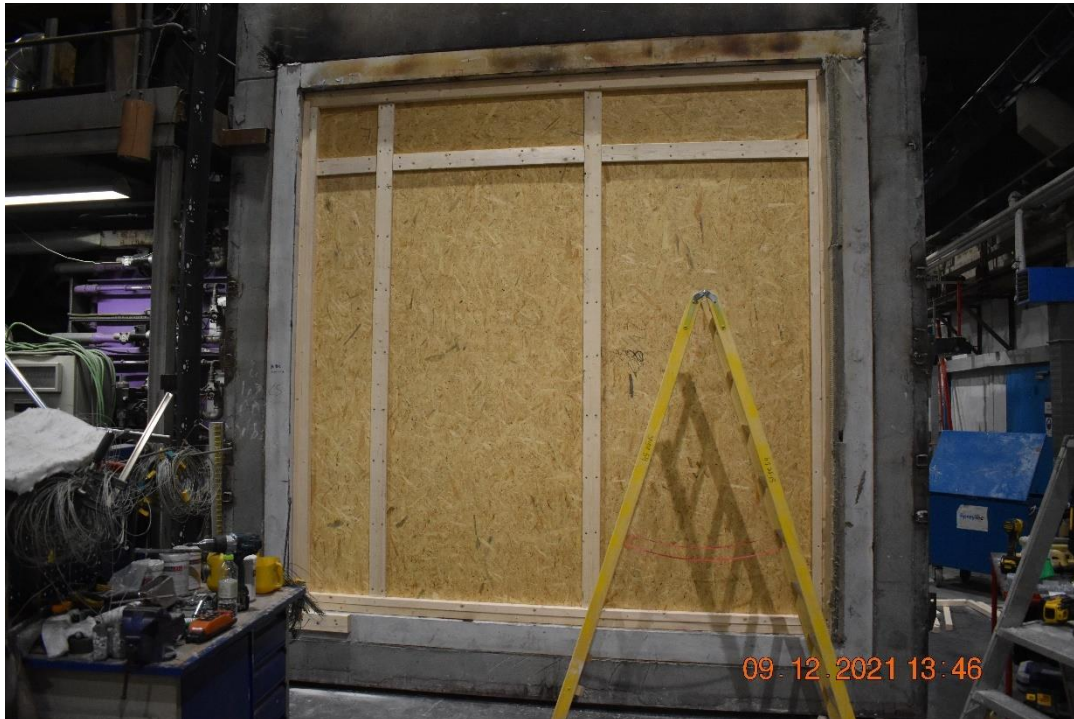
Photo No. 3 Finished wall unexposed side before application of spray on insulation.

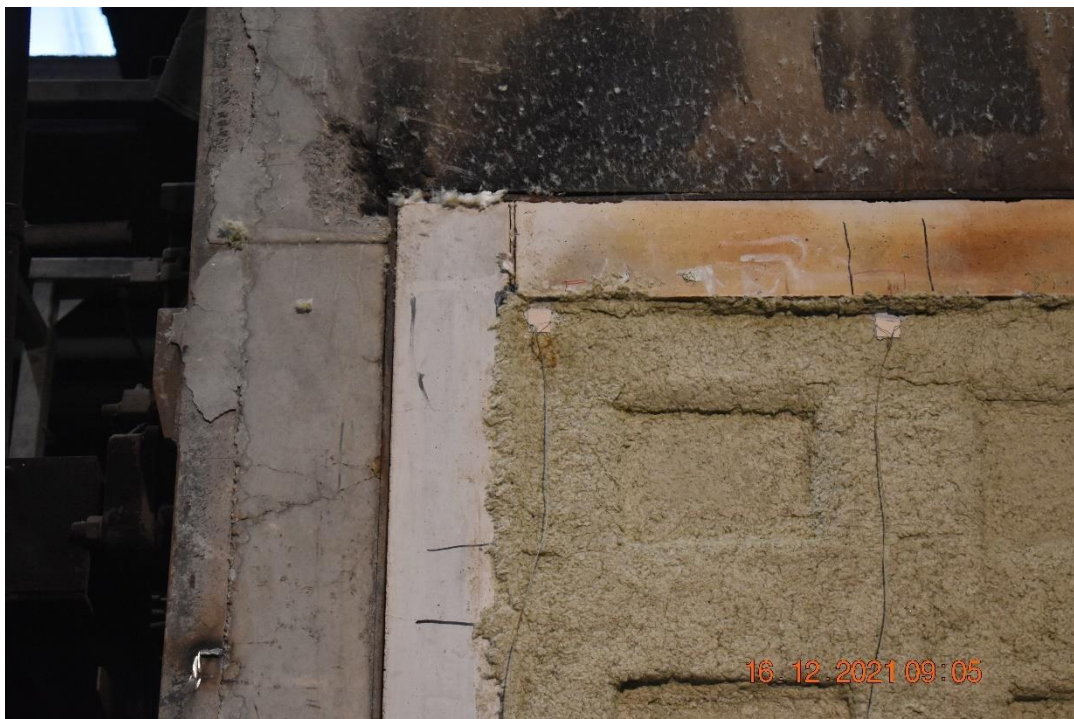
Photo No. 12 Start of discoloration top left corner.

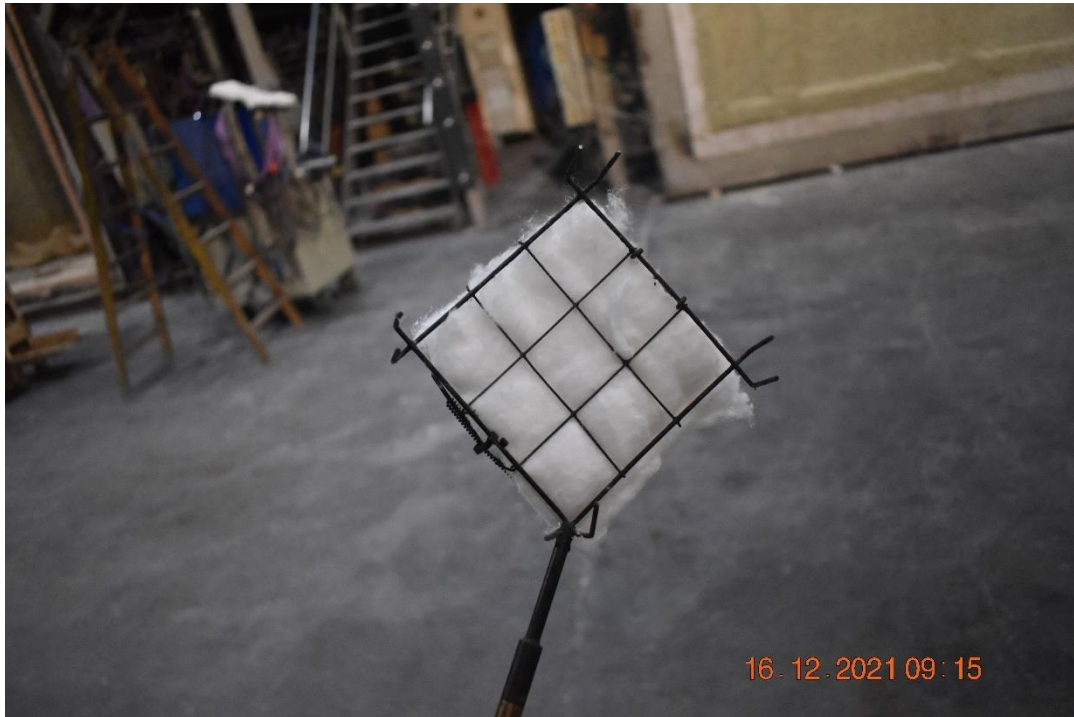
Photo No. 13 Cotton pad result top left corner at 59 minutes of testing.

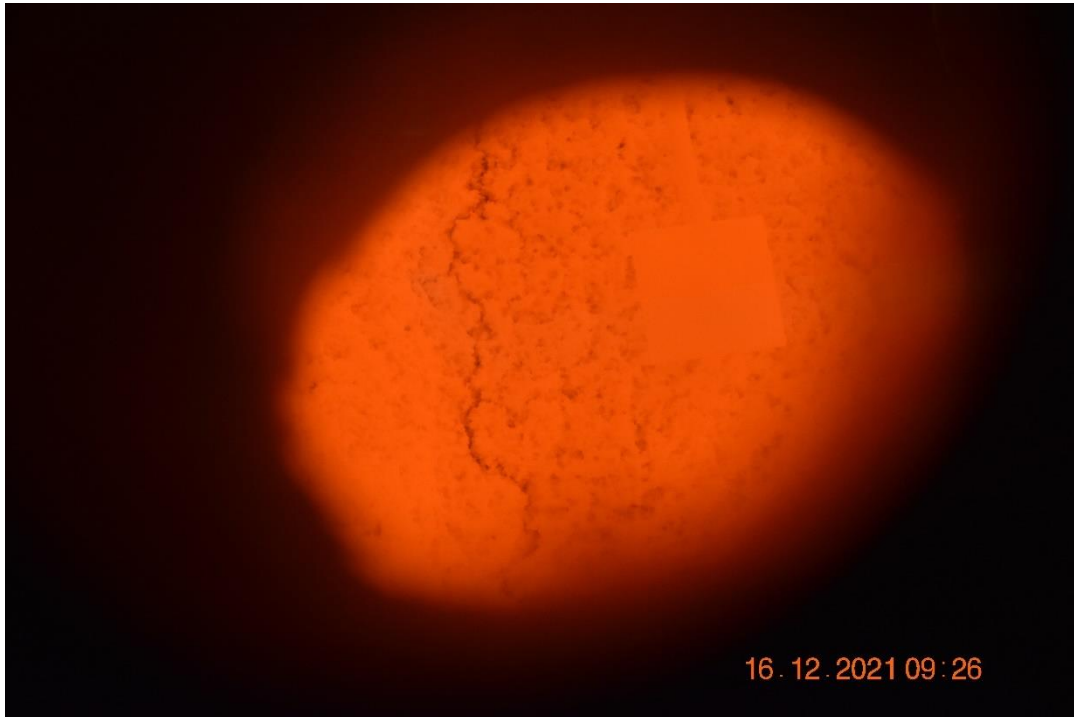
Photo No. 15 Crack in insulation exposed side after 70 minutes of testing.

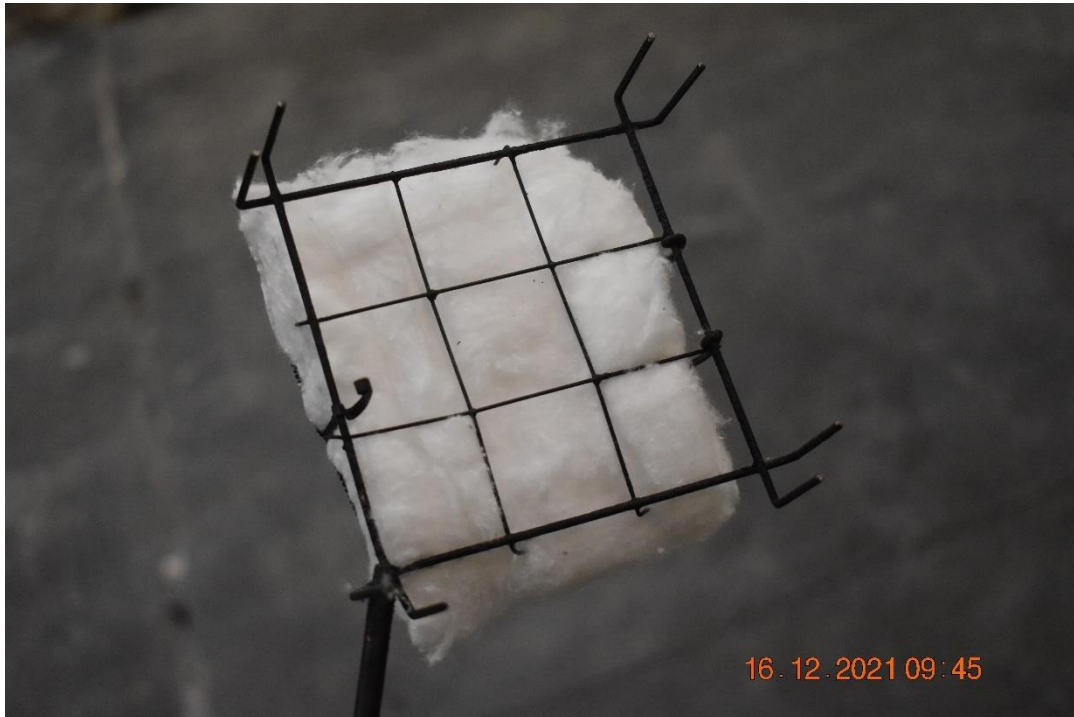
Photo No. 17 Cotton pad result top left corner at 89 minutes of testing.

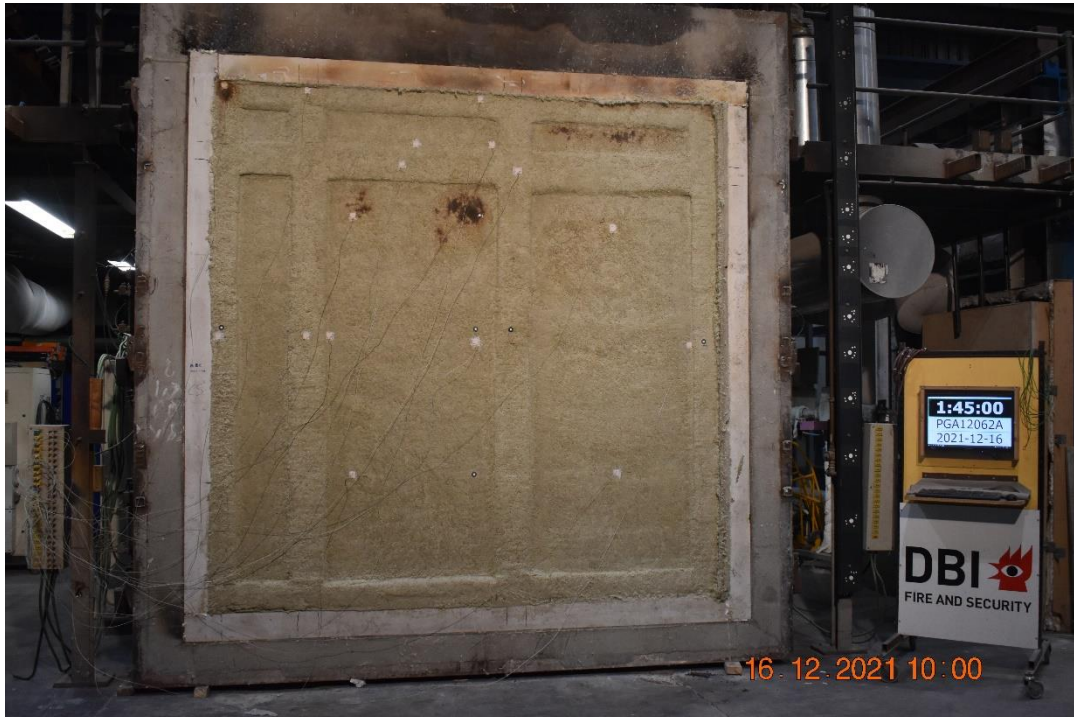
Photo No. 19 Increase in areas with discoloration after 105 minutes of testing.

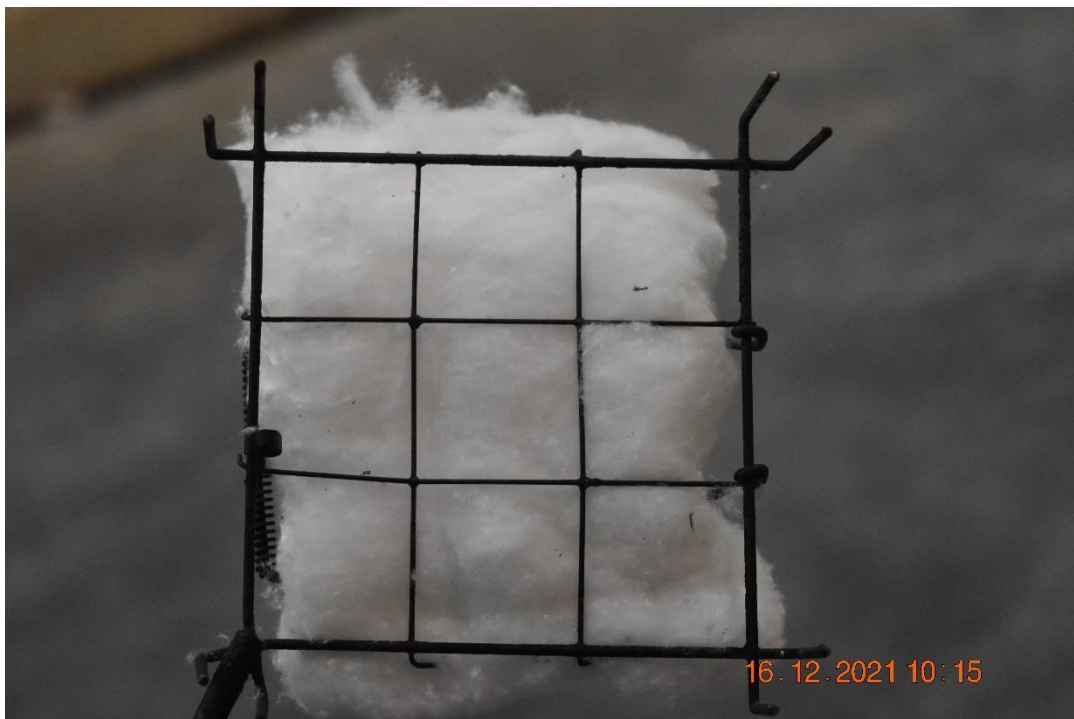
Photo No. 20 Cotton pad result top left corner at 119 minutes of testing.

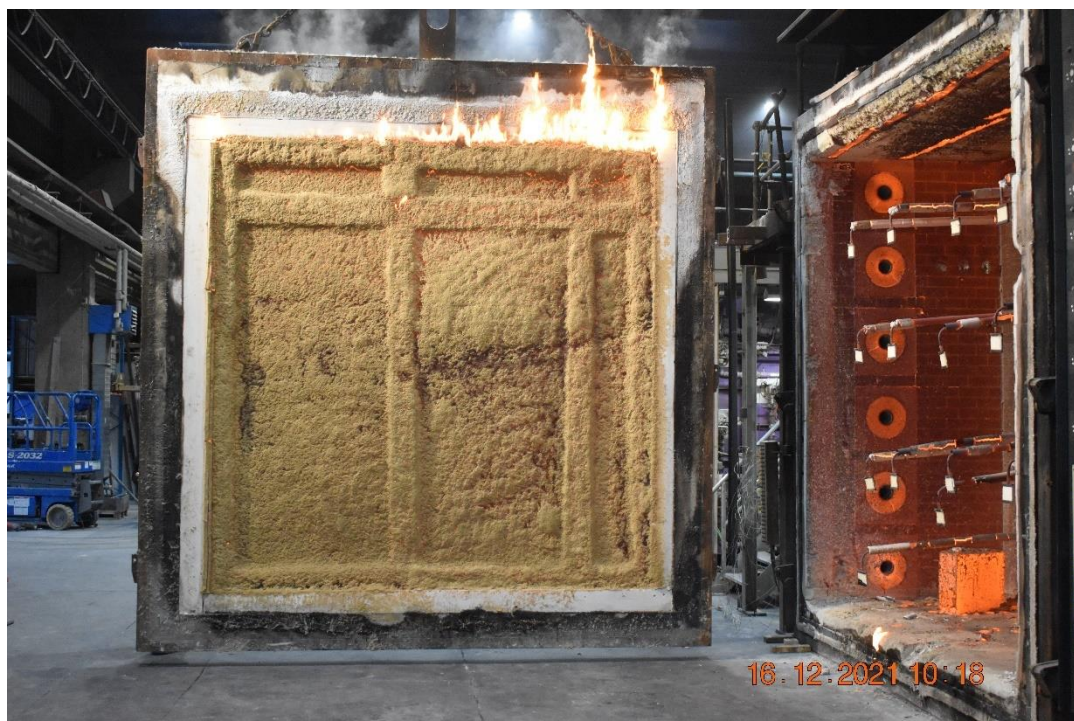
Photo No. 22 Exposed side of test specimen after 121 minutes of testing.
